NL INDUSTRIES/TARACORP SUPERFUND SITE GROUP
2209 Quarry Drive, Suite C-35
Reading, PA 19609
Telephone: (610) 670-7310
Facsimile: (610) 670-7311

Re: NL Industries/Taracorp Superfund Site; Granite City, Illinois
First 2022 Semi-Annual Operation and Maintenance Inspection (June 28-29, 2022)

**NL Industries/Taracorp Superfund Site
Inspection Log - Operation and Maintenance**

Inspection Date: June 28, 2022

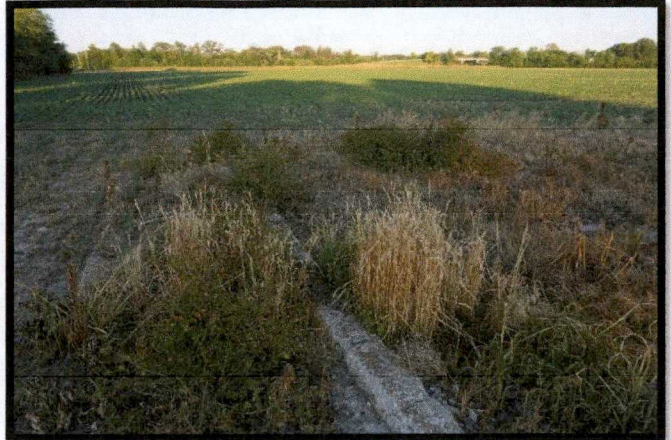
Photograph 14: Sand Road property, concrete foundation.

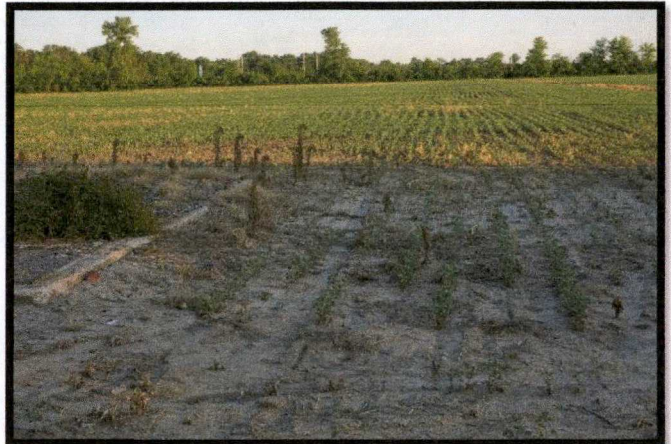
Photograph 16: Sand Road property, vegetation on south side of concrete foundation.
